## SITE CERTIFICATION SUMMARY

This Site Certification Summary provides information about the **Oxford, Ohio, Site**. The U.S. Department of Energy Office of Legacy Management is responsible for long-term stewardship of the site under the **Formerly Utilized Sites Remedial Action Program**.

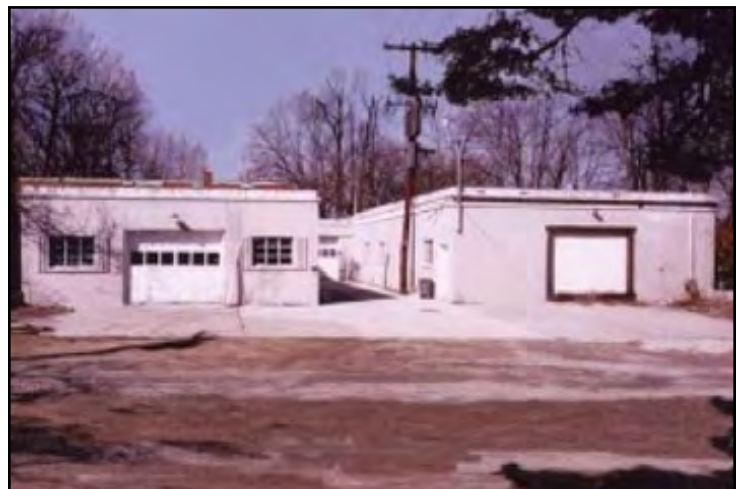
The Alba Craft Laboratory building before remediation (date unknown).

*Map of the excavation areas at the Alba Craft Laboratory building and vicinity properties. (Click image to enlarge.)*

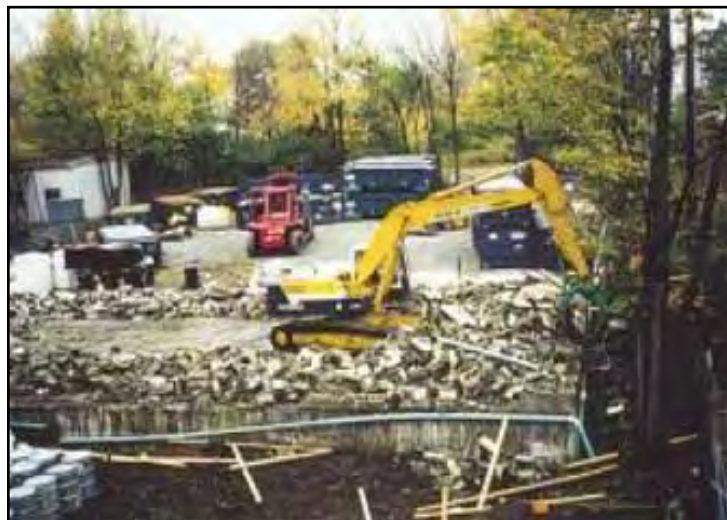
*Demolition of the Alba Craft Laboratory building (October 1994).*
